The following information was provided by Robert Kembel. He graciously shared his experience in rebuilding the blower assy. In his SR-2000

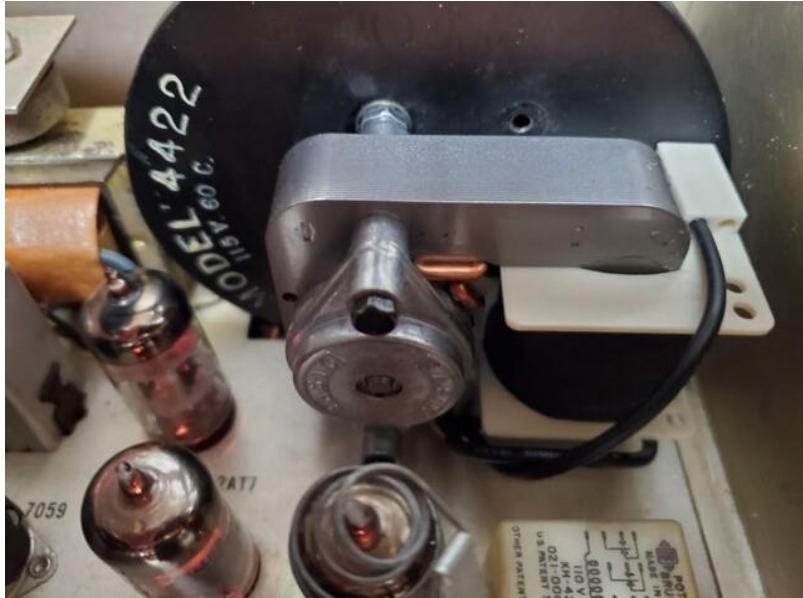
With the motor in place, I was ready to tackle the shaft issue (motor shaft = 3/16" blower squirrel cage hole = 1/4"). I remembered that some Heathkit knobs used an insert to adapt the 1/4" knob hole to a 3/16" shaft and sure enough, that was just what was needed. The squirrel cage was positioned so that it cleared the opening cover plate, the set screws tightened, the AC plug on the end of the motor leads cut off (after confirming that the blower works ok), the blower reinstalled, and voila, everything now works fine. The new motor is not as deep as the one I replaced and there is now a reasonable amount of clearance between the motor and the 6AQ5 tube.

The new motor arrived and I observed that the mounting studs projected from the wrong side of the motor (opposite the shaft). I unscrewed the studs and screwed them in from the opposite (back) side. The rear motor housing is threaded to accommodate the mounting studs so I needed to use nuts on the front side to hold the motor together. With the mounting studs now extending out the front (shaft) side of the motor, I could see that the motor would fit and the studs were long enough to mount the motor to the blower housing. I did need to add a washer between each of the mounting studs and blower housing so the motor winding bobbin cleared the blower housing, otherwise, the motor ended up being somewhat cocked. When the motor is mounted, the winding bobbin should face towards the PA cage.

The harder part for many might be adapting the 3/16" motor shaft to the 1/4" hole in the squirrel cage. I used a bushing from a Heathkit knob insert which was a perfect fit. One may also be able to use a piece of brass tubing, such as the following:
